**ENERGY
EFFICIENT TIME
TABLES**

RESULTS ECO-DRIVING PROJECT LINEAS (2016-2017)

INEFFICIENT BELGIAN TIMETABLES (P100) AND UNFORESEEN RESTRICTIVE SIGNALS BLOCK ECO-DRIVING DEVELOPMENTS

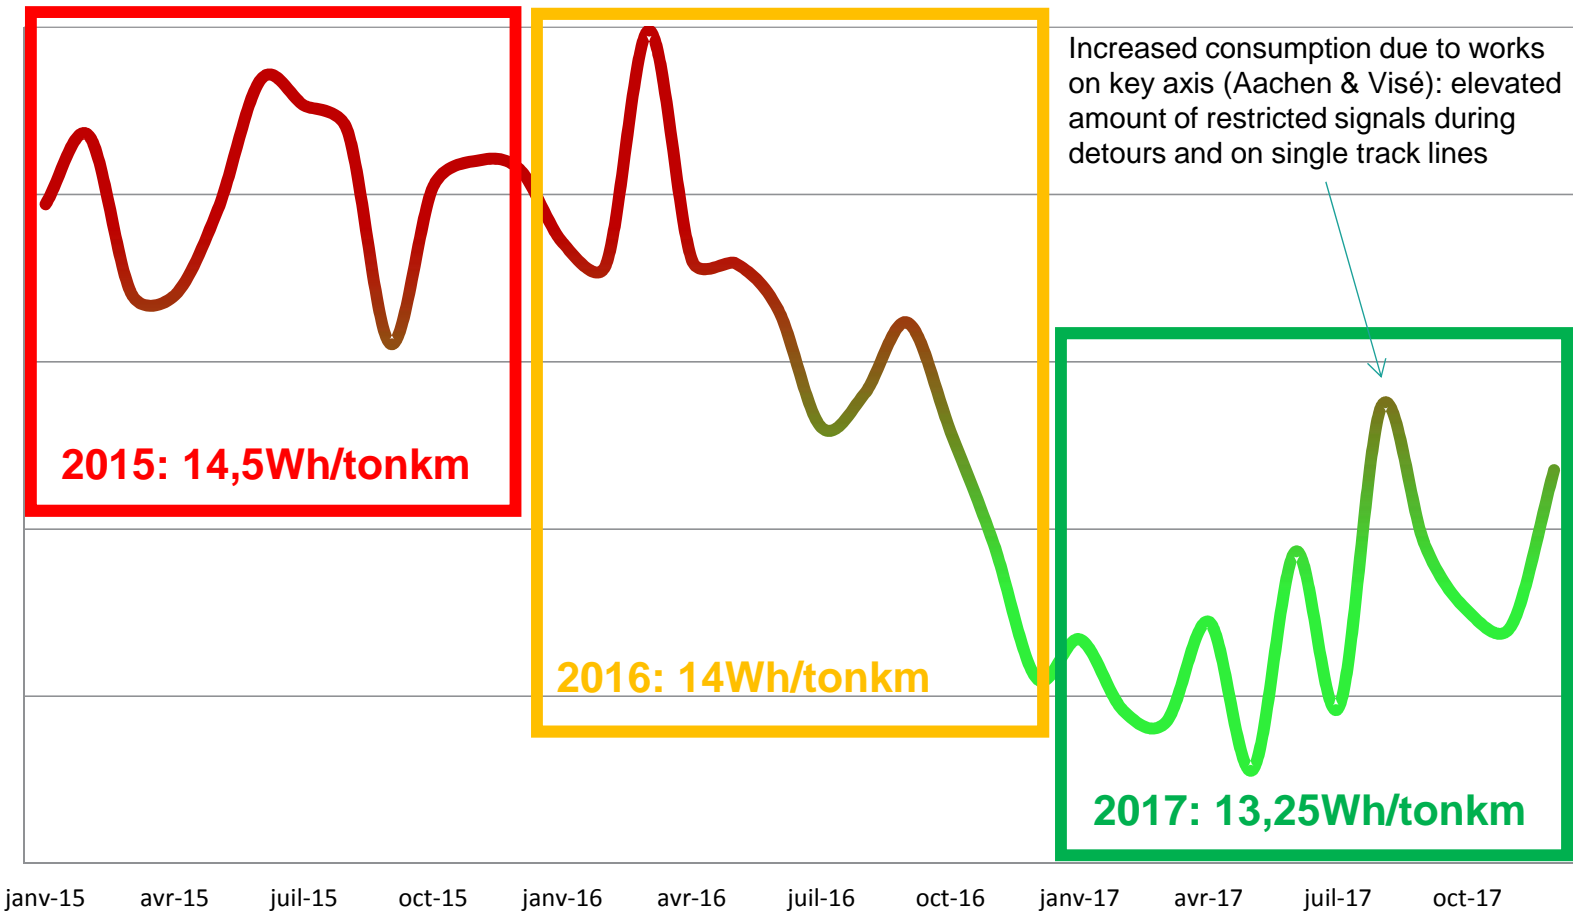
Electricity consumption Belgium 2015-2017 (Wh/tonkm)

MEASURED) CONSUMPTION DECREASE OF 8,75% OVER THE LAST 2 YEARS

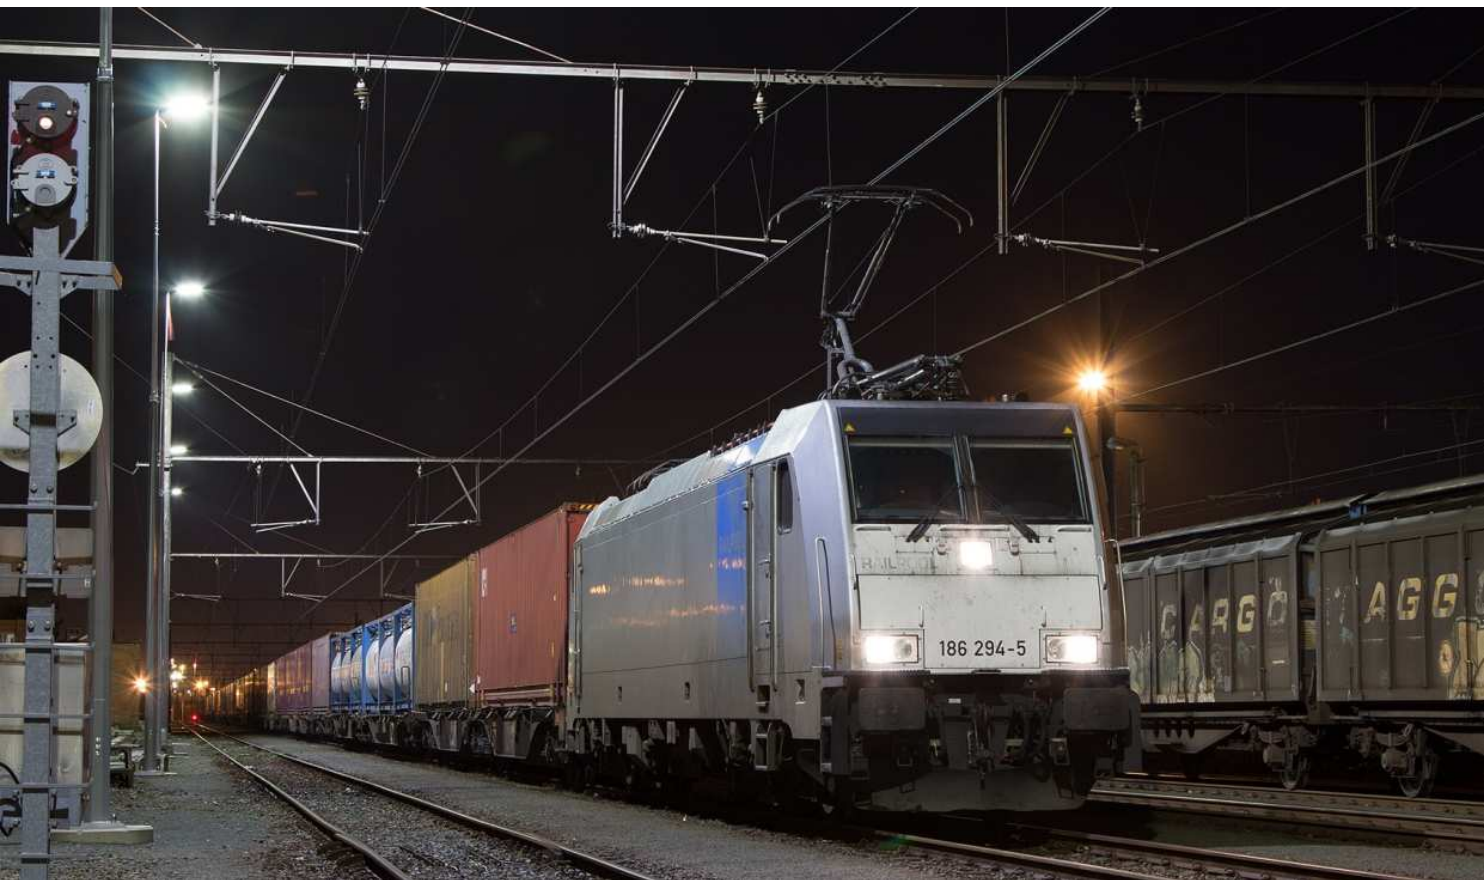
EXAMPLE: ZEEBRUGES – MONTZEN (DRIVER: LAURENT JOSEPH)

E 40043 : 1352t + 84t (Traxx MS)
Railpath : P100
Vmax : 100km/h
Zeebruges – Montzen : 252 km
Top ECO-Driver : Laurent Joseph

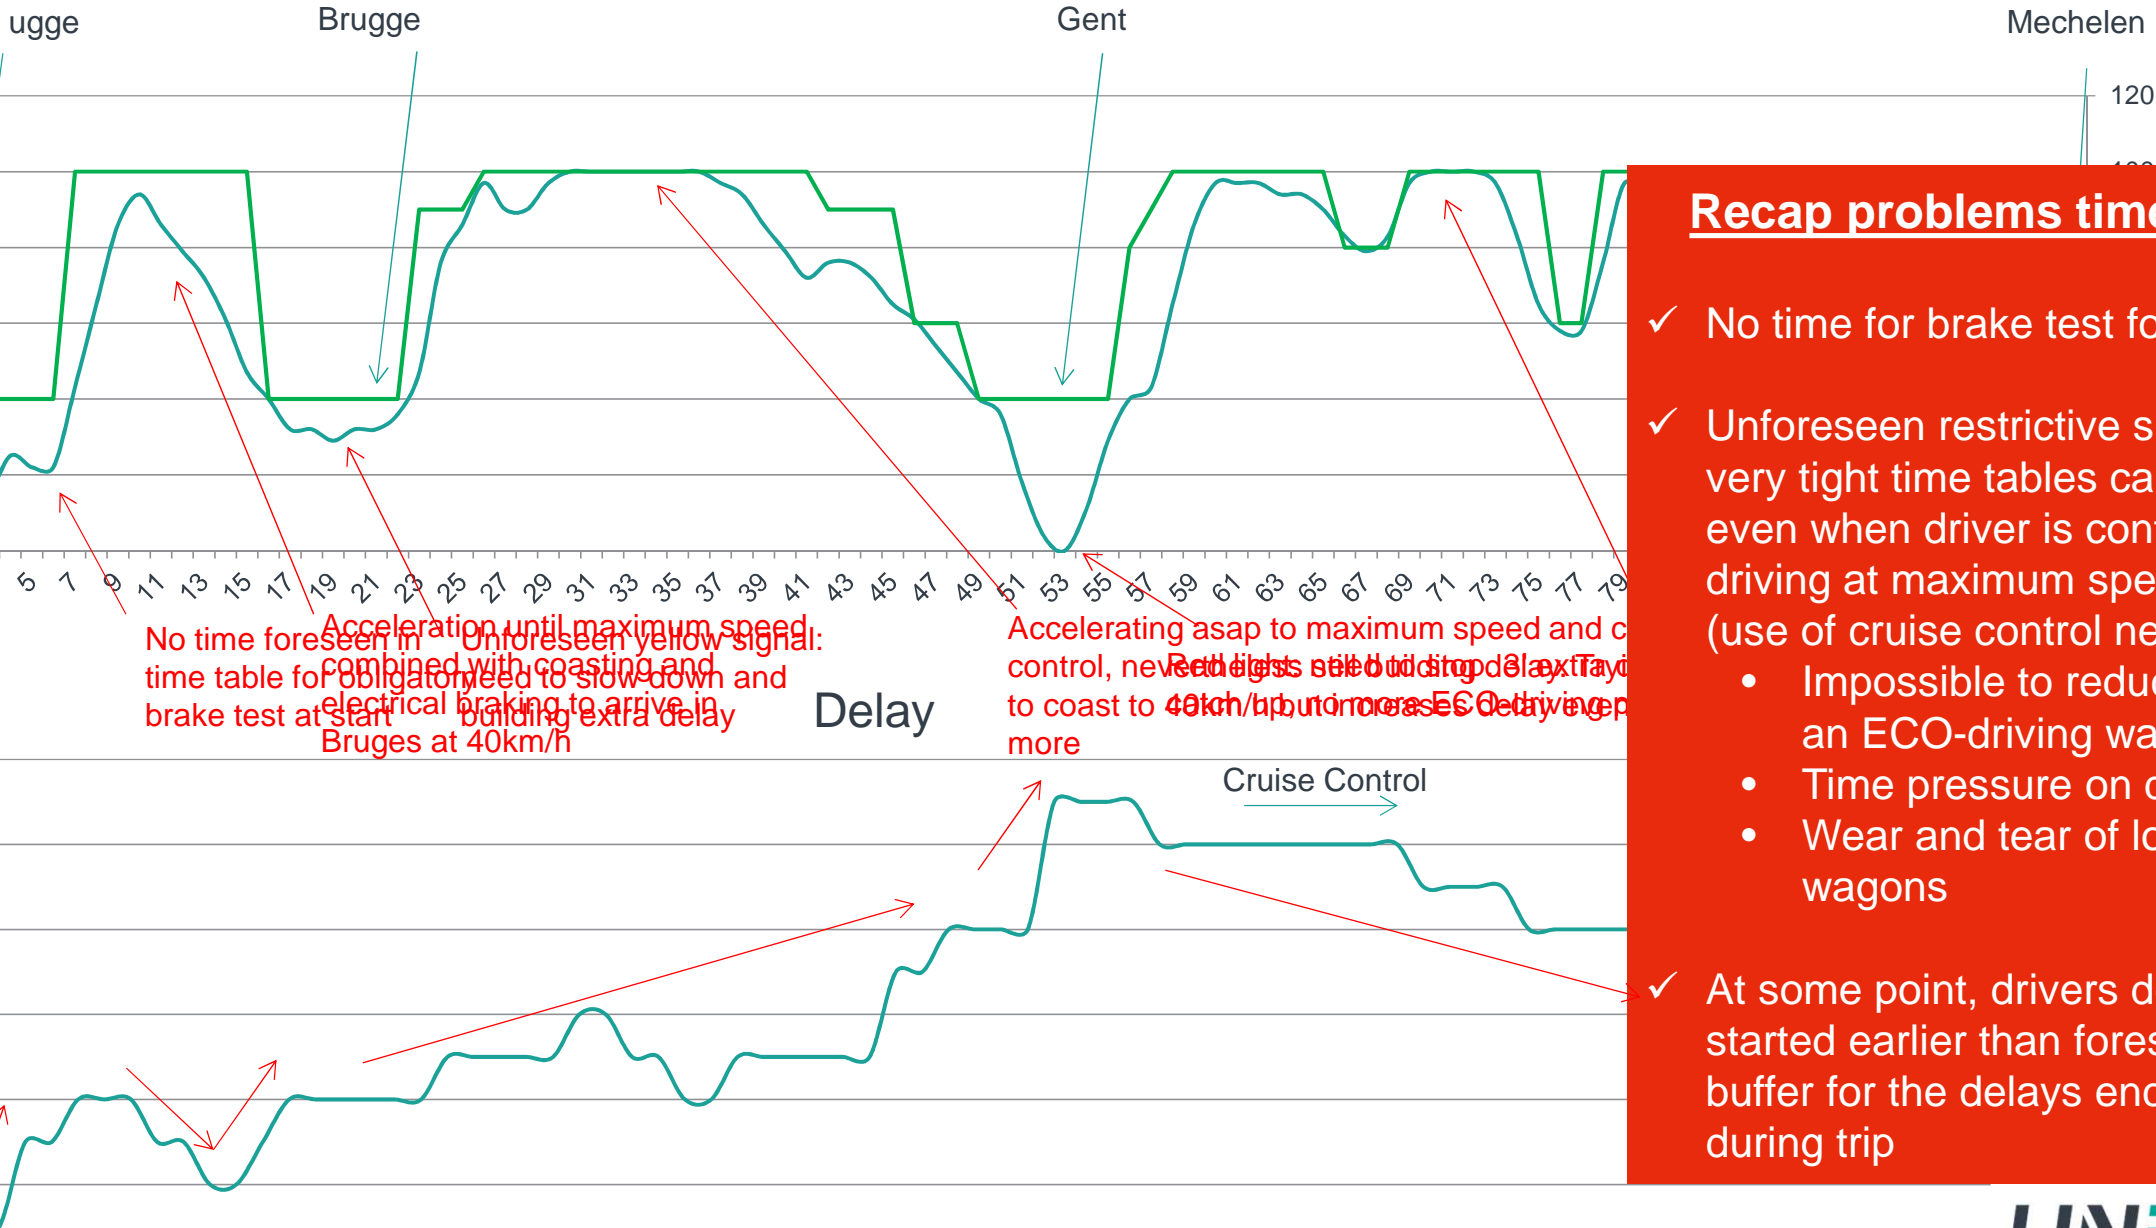
I:Zeebruges – Mechelen: Unforeseen stops in very tight time table cause delays even when driving at max s

No time foreseen in time table for obligatory brake test at start combined with coasting and electrical braking to arrive in Brugge at 40km/h

Acceleration until maximum speed: Unforeseen yellow signal: combined with coasting and electrical braking to arrive in Brugge at 40km/h

Accelerating asap to maximum speed and control, never reaching 40km/h but more to coast to 40km/h but more

Recap problems time table

- ✓ No time for brake test forese
- ✓ Unforeseen restrictive signal very tight time tables cause o even when driver is continuo driving at maximum speed (use of cruise control necess
 - Impossible to reduce de an ECO-driving way
 - Time pressure on driver
 - Wear and tear of loc an wagons
- ✓ At some point, drivers despe started earlier than foreseen buffer for the delays encount during trip
