# *Defect detection of Railway switch using 3D scanning*

**Abstract**—Purpose of this paper is to conduct a feasibility study to examine the defects in switch rails using 3-dimensional scanning. The switch defect detection tools are rare and expensive. 3-dimensional scans of a fabric and a damaged switch have been taken by the Xbox Kinect device. Since the boundary condition in each switch blade is different, image processing algorithms should start with noise reduction and then finding the damage location comparing the fabric and the damaged sample. Besides, failure mode and effects analysis approach have been used for risk analysis. With this method, maintenance priority for each switch can be determined. As a result, risk priority number calculated for maintenance management, depend on the reliability of each equipment. The proposed defect detection method with Xbox Kinect camera can lead to a more efficient resource planning and can optimize current maintenance management systems. Moreover, failure forecasting related to local condition is possible.

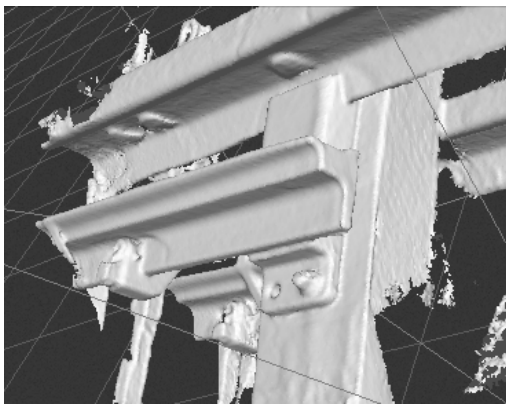
Fig. 2. Undamaged UIC60 switch blade in 300 radius 3Dmodel scanning by Kinect device

For testing this method, an undamaged and a damaged UIC60 switch blade with radius 300 were scanned by Kinect camera. The undamaged UIC60 switch blade with radius 300 while scanning with Kinect device is shown in figure 1 and the final 3D model of the undamaged switch blade is shown in figure 2 & 3 and the final 3D model of the damaged switch blade is shown in figure 4 & 5.
